MISCELLANEOUS PAPER HL-89-4

SCOUR PROTECTION FOR MORGANTOWN DAM MONONGAHELA RIVER, WEST VIRGINIA

Hydraulic Model Investigation

August 1989

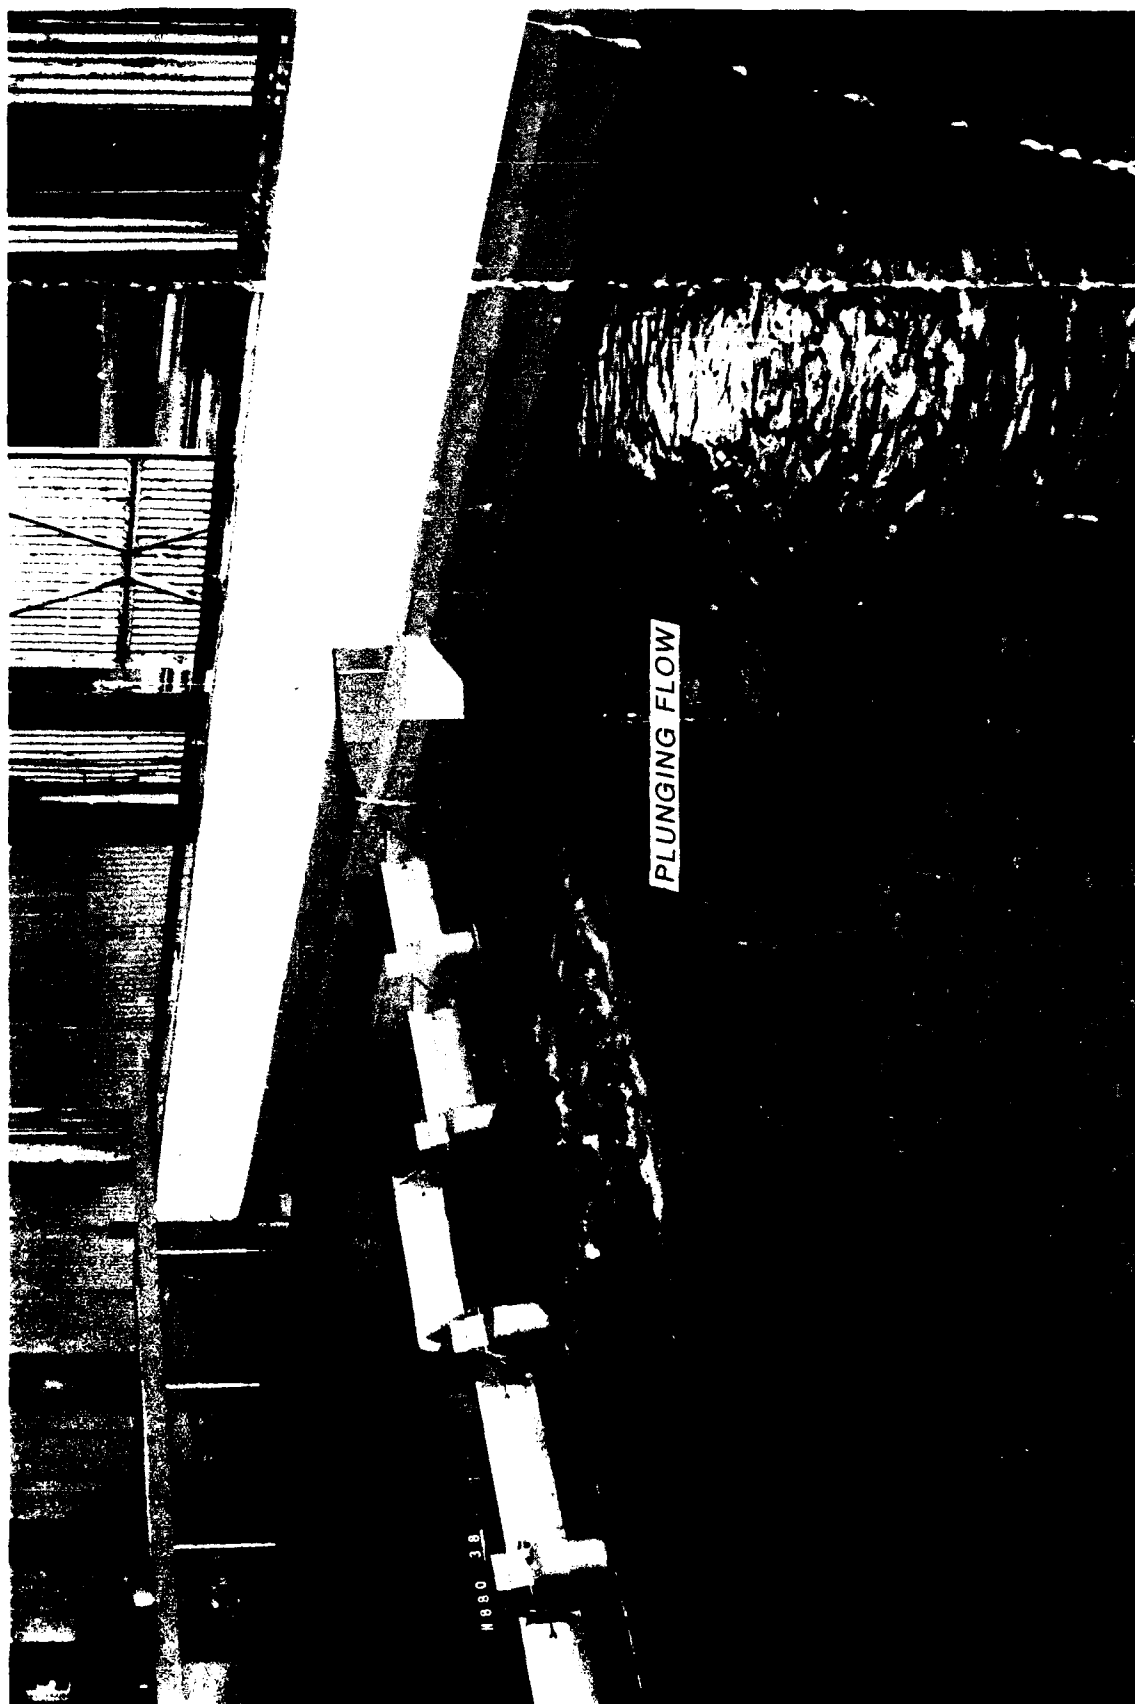
displaced by the flow plunging over the downstream wall of the last barge as shown in Photo 26. The downstream wall of the third barge was lowered to 6 ft, type 21 scour protection plan shown in Plate 21. Stones 4 to 5 ft in diameter were placed horizontally for a distance of 25 ft downstream from the barges. Flow conditions were improved because the flow no longer plunged over the wall of the last barge, Photo 27, but considerable turbulence and high velocity flow caused the stones downstream from the barges to be displaced.

Photo 26. Flow conditions with type 20 scour protection plan, normal upper pool el 814, minimum tailwater el 797, gate 3 open full

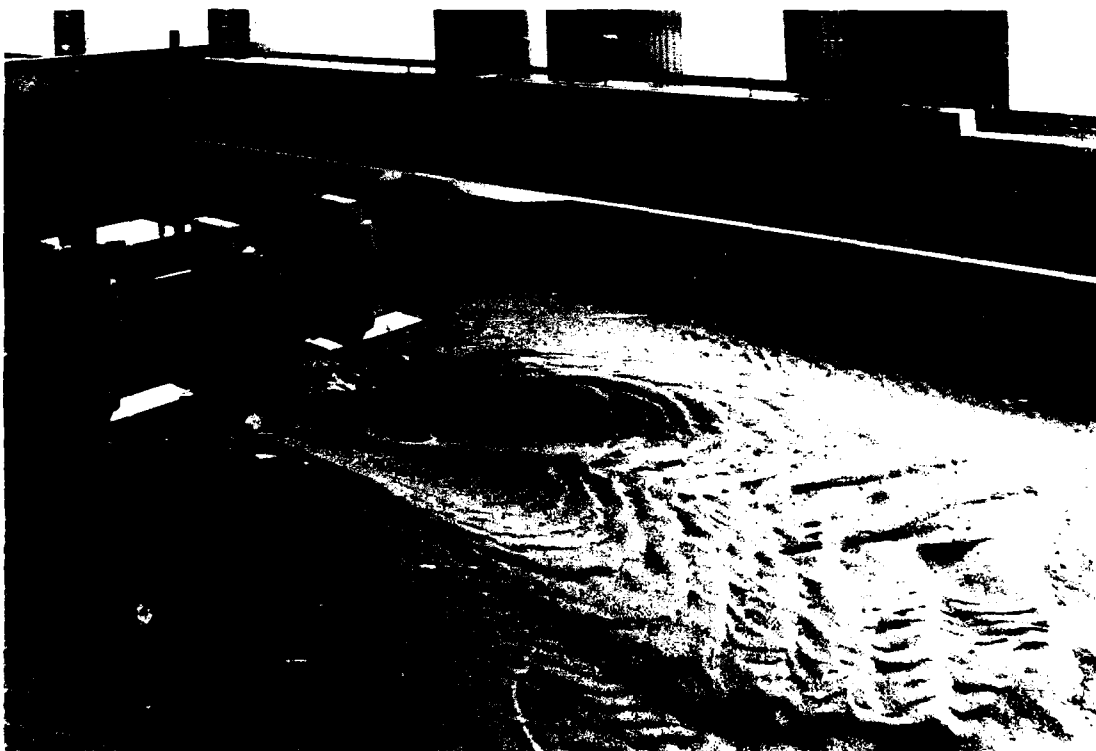
29. The walls between the first and second barges were lowered to 6 ft and the 3-ft vertical sill at the end of the existing structure was removed because prototype construction was not considered practical. This was the type 22 scour protection plan shown in Plate 22. Flow conditions with this design for gate 3 opened fully to the normal upper pool and minimum tailwater el 797 are shown in Photo 28. The 4- to 5-ft-diameter stones placed downstream from the barges were displaced for these conditions and also when tested with normal upper pool, a 6-ft gate opening, and normal and minimum tailwater. Tests were conducted with gate 3 opened 6 ft because this gate opening was sufficient to pass ice and previous tests had indicated that an acceptable design utilizing barge revetment could not be developed for the flow conditions caused by operations with one gate opened fully to the normal pool and minimum tailwater, due to topography constraints below the dam. Flow conditions with normal upper pool, a 6-ft gate opening, and normal and minimum tailwater are shown in Photo 29. Scour in the exit channel after 5 hr of operation with these conditions is shown in Photo 30.

Photo 30. Scour downstream of type 22 scour protection plan after 5 hr of operation; normal upper pool, gate 3 open 6 ft

38. The type 22 scour protection plan, while less than desirable hydraulically than type 12, should be adequate for ice and debris passage with gate openings equal to or less than 6 ft. Scour downstream from the barges can be expected during these operations, but this plan should prevent undermining of the existing stilling basin. Model results indicate that flow conditions for normal operating conditions are certainly capable of scouring a streambed.

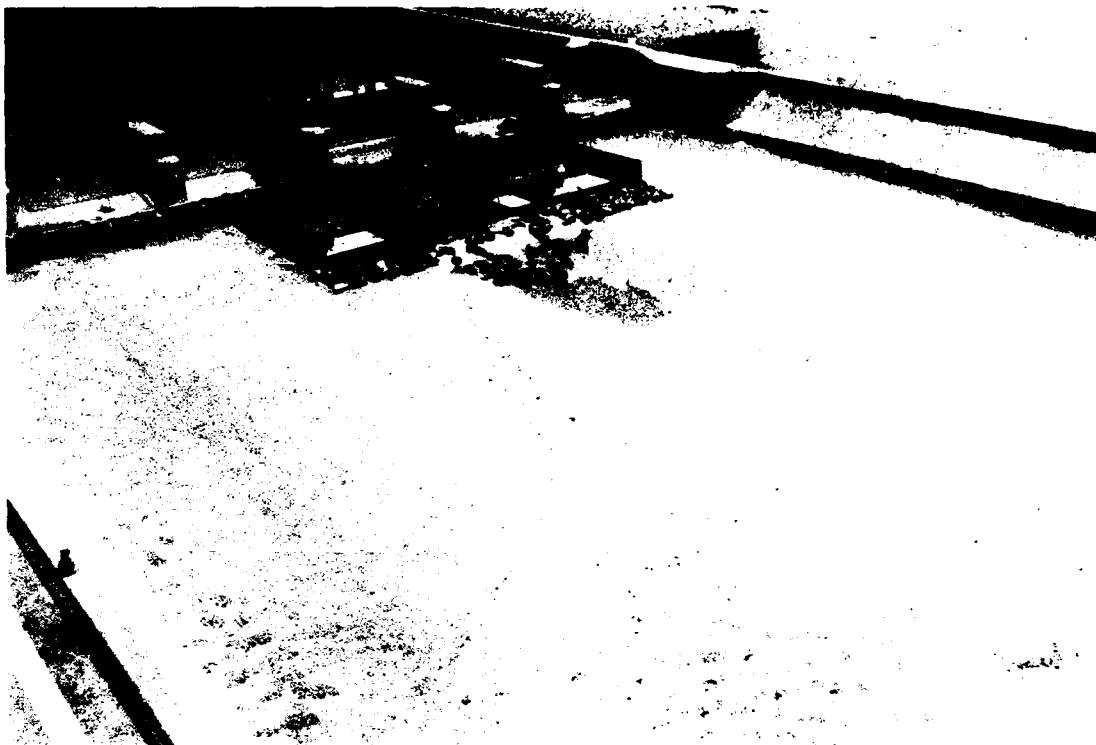
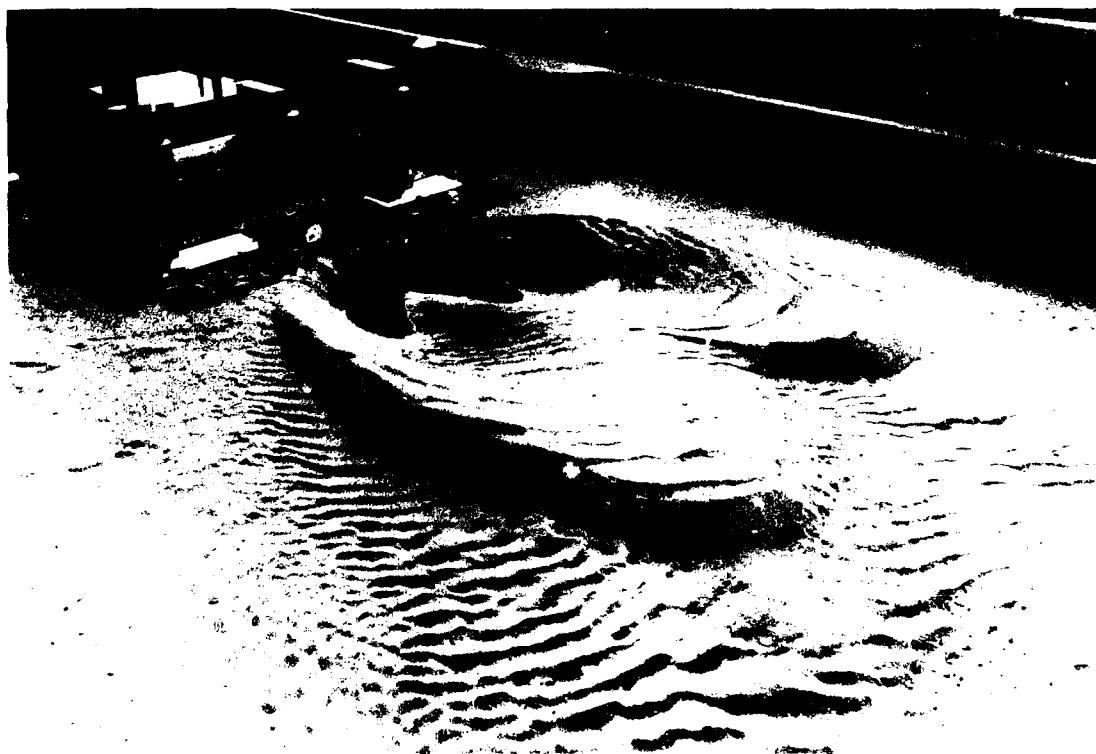
31. The walls between the first and second barges were lowered to 9 ft with the remaining walls 6 ft high to form the type 24 scour protection plan shown in Plate 24. A test was conducted for 5 hr with gate 3 opened 6 ft, normal upper pool and minimum tailwater and scour in the exit channel after completion of the test is shown in Photo 33a. The stones failed due to displacement by the flow conditions shown in Photo 34a. Results from another test conducted with the normal tailwater of 803.6 are shown in Photo 33b and indicate the stones failed again. Flow conditions during the test are shown in Photo 34b.

Photo 33. Scour downstream of type 24 scour protection plan after 5 hr of operation; normal upper pool el 814, gate 3 open 6 ft

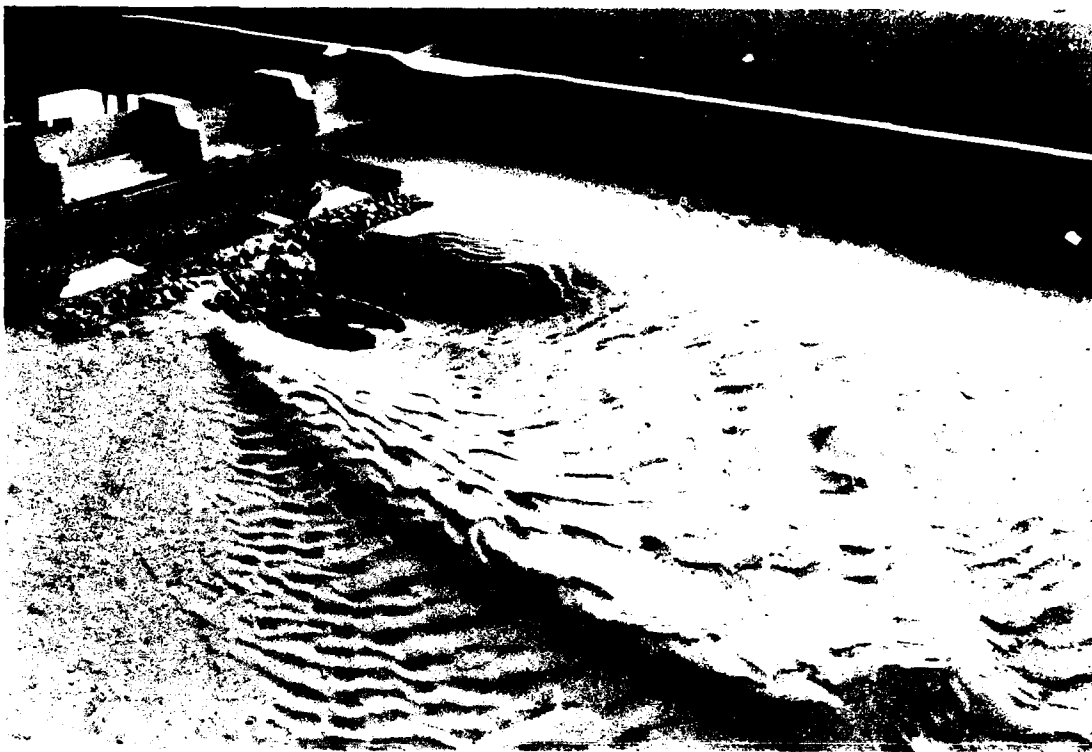
32. The 3-ft-high sill at the end of the existing structure improved energy dissipation in the barges, but it was not considered a feasible modification. The walls between all the barges and the downstream wall of the last barge were lowered to 6 ft. This modification is shown in Plate 25 and was noted as the type 25 scour protection plan. Tests were conducted with gate 3 opened 6 ft, normal upper pool, and tailwaters of 797 and 803.6. Results from the test with a tailwater of 797 are shown in Photo 35a and indicate failure of the stones. Flow conditions during the test are shown in Photo 36a. Scour in the exit channel after 5 hr of operation with a normal tailwater of 803.6 is shown in Photo 35b and indicate stone protection failed during this test. Flow conditions during the test are shown in Photo 36b.

Photo 35. Scour downstream of type 25 scour protection plan after 5 hr of operation; normal upper pool el 814, gate 3 open 6 ft

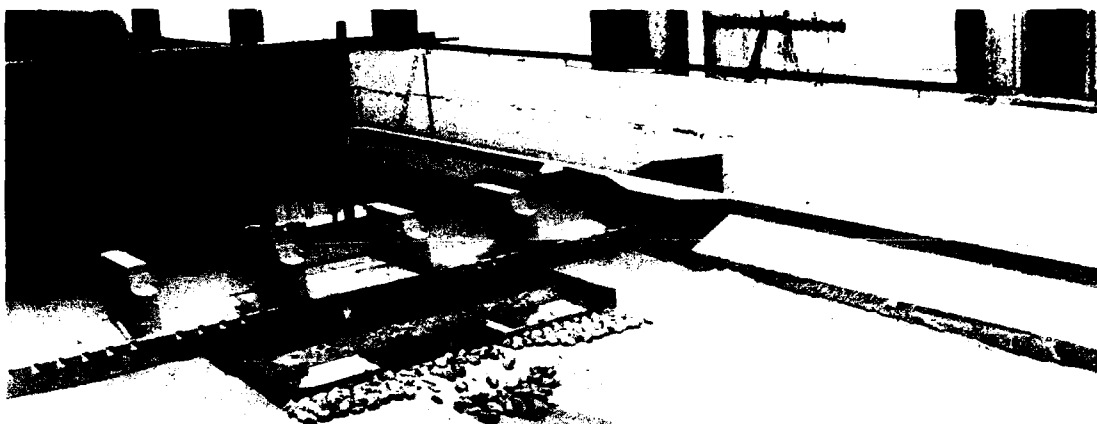
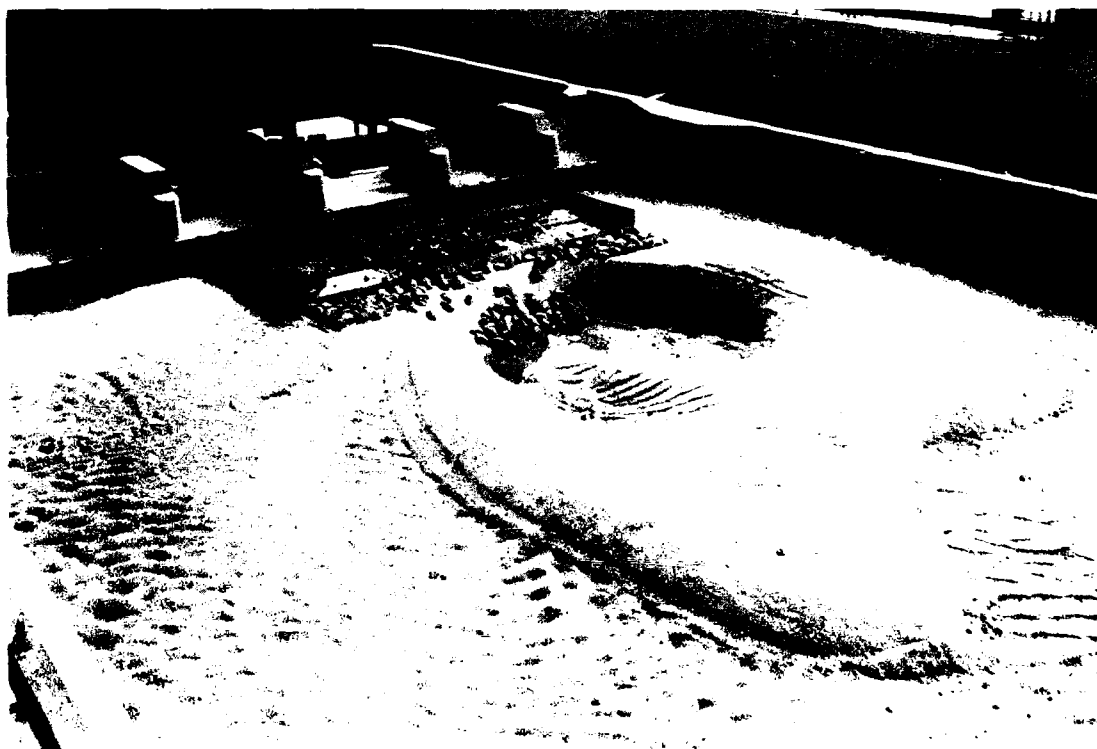
gate opening are shown in Photo 38b and the scour after 5 hr of operation with these flow conditions is shown in Photo 37b.

Photo 37. Scour downstream of type 26 scour protection plan after 5 hr of operation; normal upper pool el 814, gate 3 open 6 ft

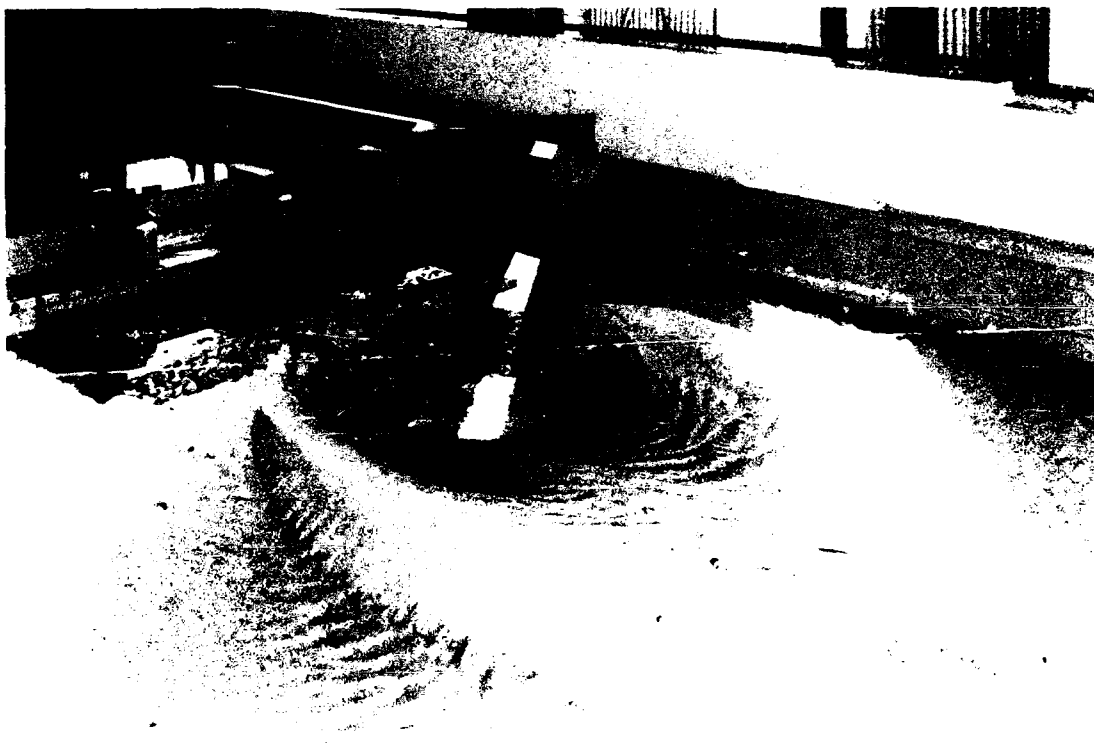
34. The wall between the first and second barges are raised to 12 ft to form the type 27 scour protection plan, shown in Plate 27. This plan was tested with gate 3 opened 6 ft, normal upper pool, and tailwaters of 797 and 803.6. The results from these tests, shown in Photo 39, indicate failure of the 4- to 5-ft-diameter stones for the normal tailwater and the stones were stable for the minimum tailwater condition. Flow conditions during these tests are shown in Photo 40. Flow conditions appear worse with the lower tailwater, Photo 40a, but actually the energy dissipation is better with this flow condition.

Photo 39. Scour downstream of type 27 scour protection plan after 5 hr of operation; normal upper pool el 814, gate 3 open 6 ft
